BETTINA K. SCHNEIDER

THE RESTORATION OF A GLASS ARM CHANDELIER
FROM THE MIDDLE OF THE 19TH CENTURY
BELONGING TO THE PRUSSIAN PALACES
AND GARDENS IN BERLIN-BRANDENBURG

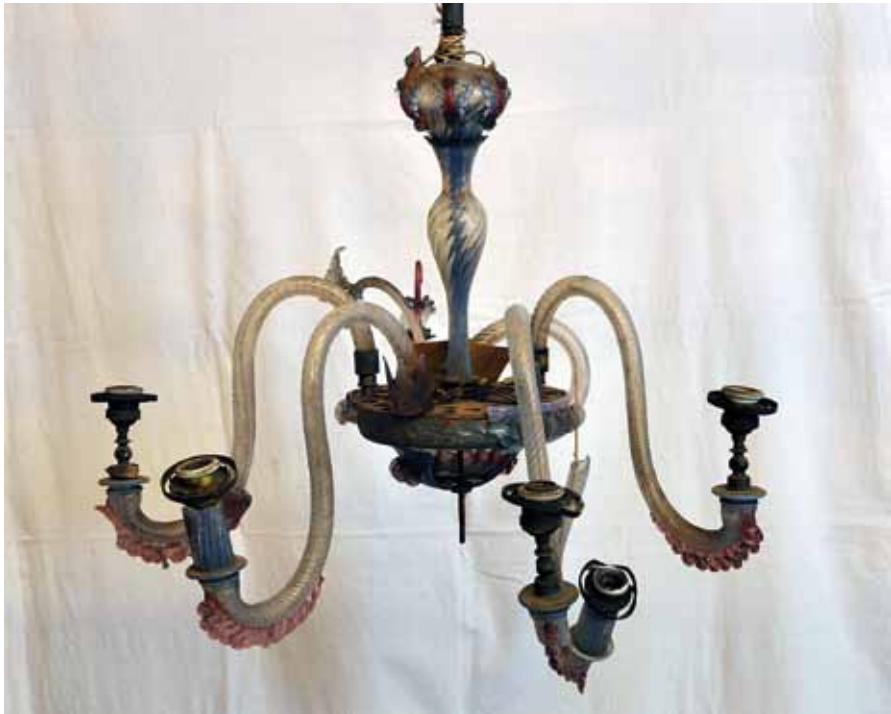
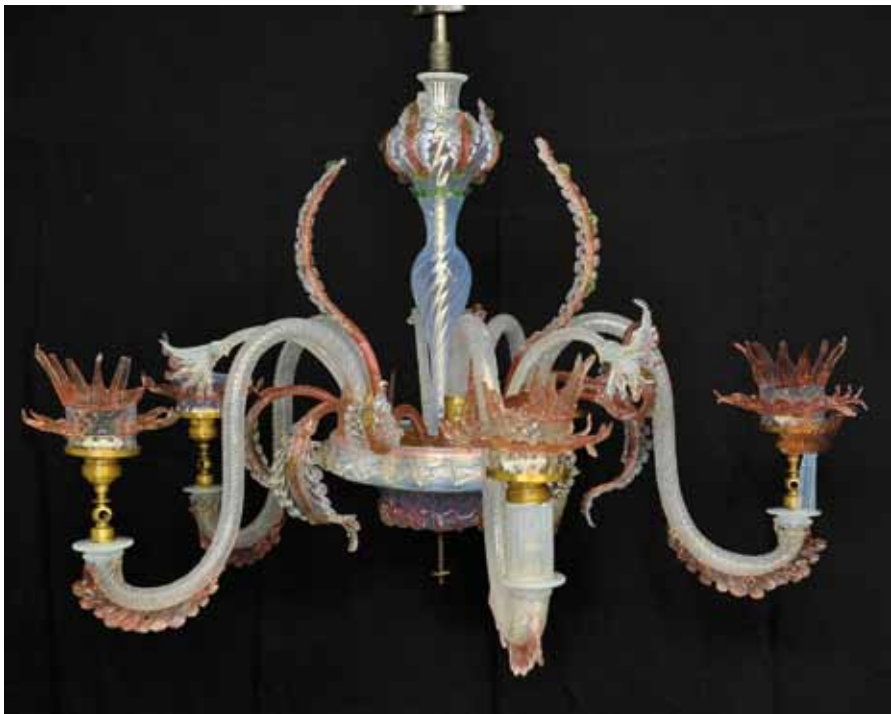
Figs. 1, 2 - Glass arm chandelier, mid-19th century, before and after restoration. Potsdam, Neue Palais, inv. VIII 1010.
